## HO-2

## Oakdale

### **Architectural Survey File**

## National Register of Historic Places Registration Form

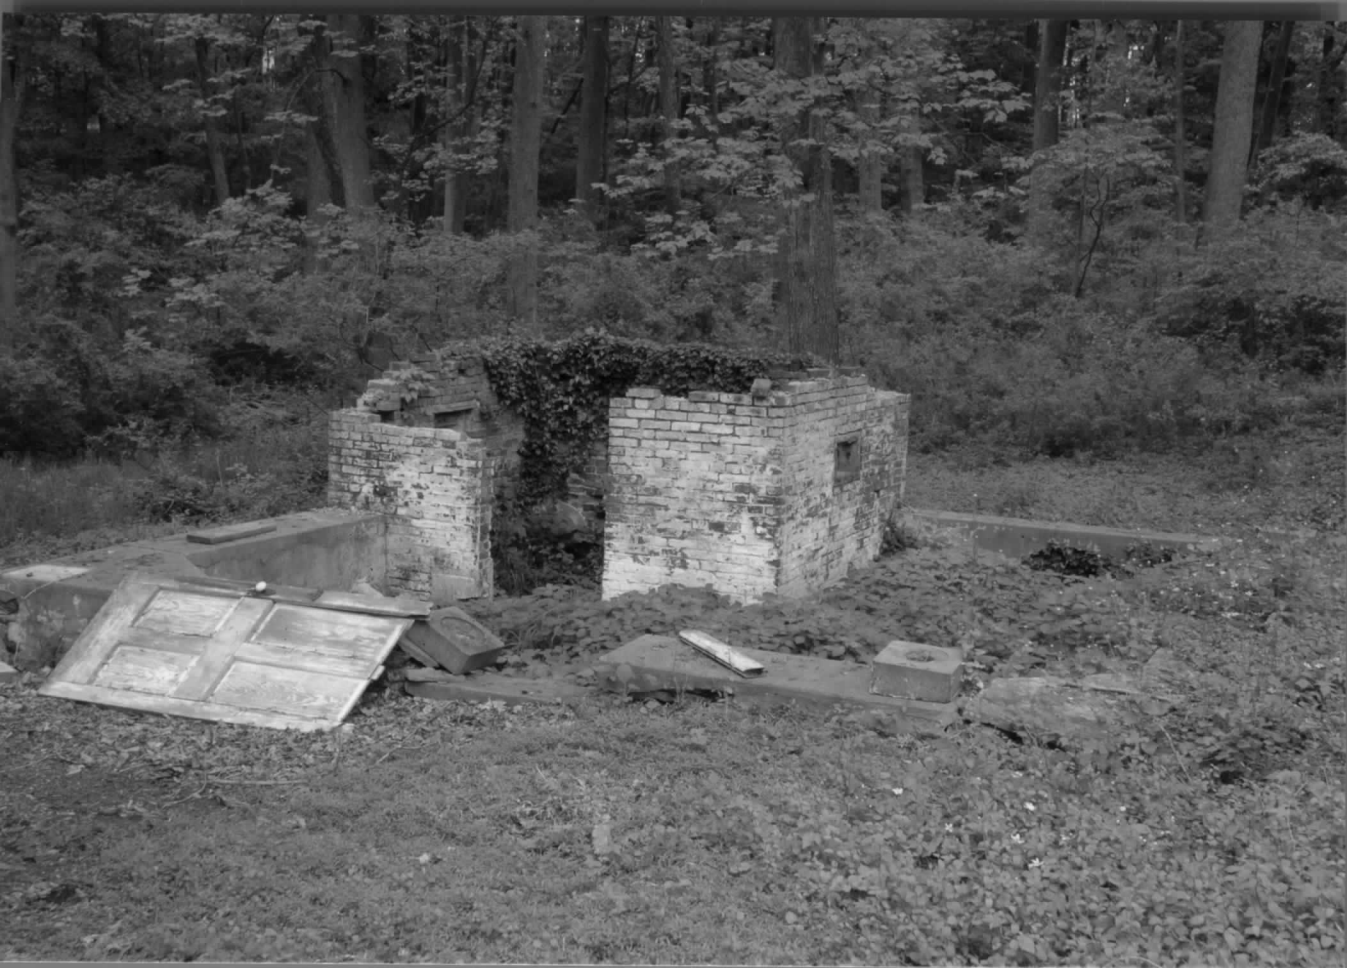
29 of 36

Springhouse, southeast & northeast  
elevations

The Springhouse is located about 175 feet southwest of the house ell, downhill and in the woods, and about 175 feet north of the pond. It is in ruins and has brick walls of five-to-one common bond. The walls are painted white and are parged at the bottom on the southeast. The roof is gone. There is a doorway on the southeast. The southwest elevation has a vent with three diamond-in-section wood bars, and the northeast elevation has a similar vent that is missing its bars. The northwest elevation has no openings. The floor is hidden by water, debris, and vegetation. The walls are two wythes thick. There is a four-panel door lying adjacent to the building, with a mortise lock and porcelain knob. There is a walled enclosure made of rubble stone with a concrete coping, on the southeast and northeast. The coping is at grade on the northeast, steps down in the center of the southwest wall, and is about 2 feet above grade at the southwest end. The coping has some concrete plinths sitting on top and must have held columns for an open porch added to two sides of the building. This enclosure is filled with vegetation. The water exits the springhouse near the south door jamb and passes through an opening in the southwest wall of the enclosure, and runs underground (possibly in a terra cotta pipe, some of which survives in the opening) to a stream about 30 feet southwest of the building.

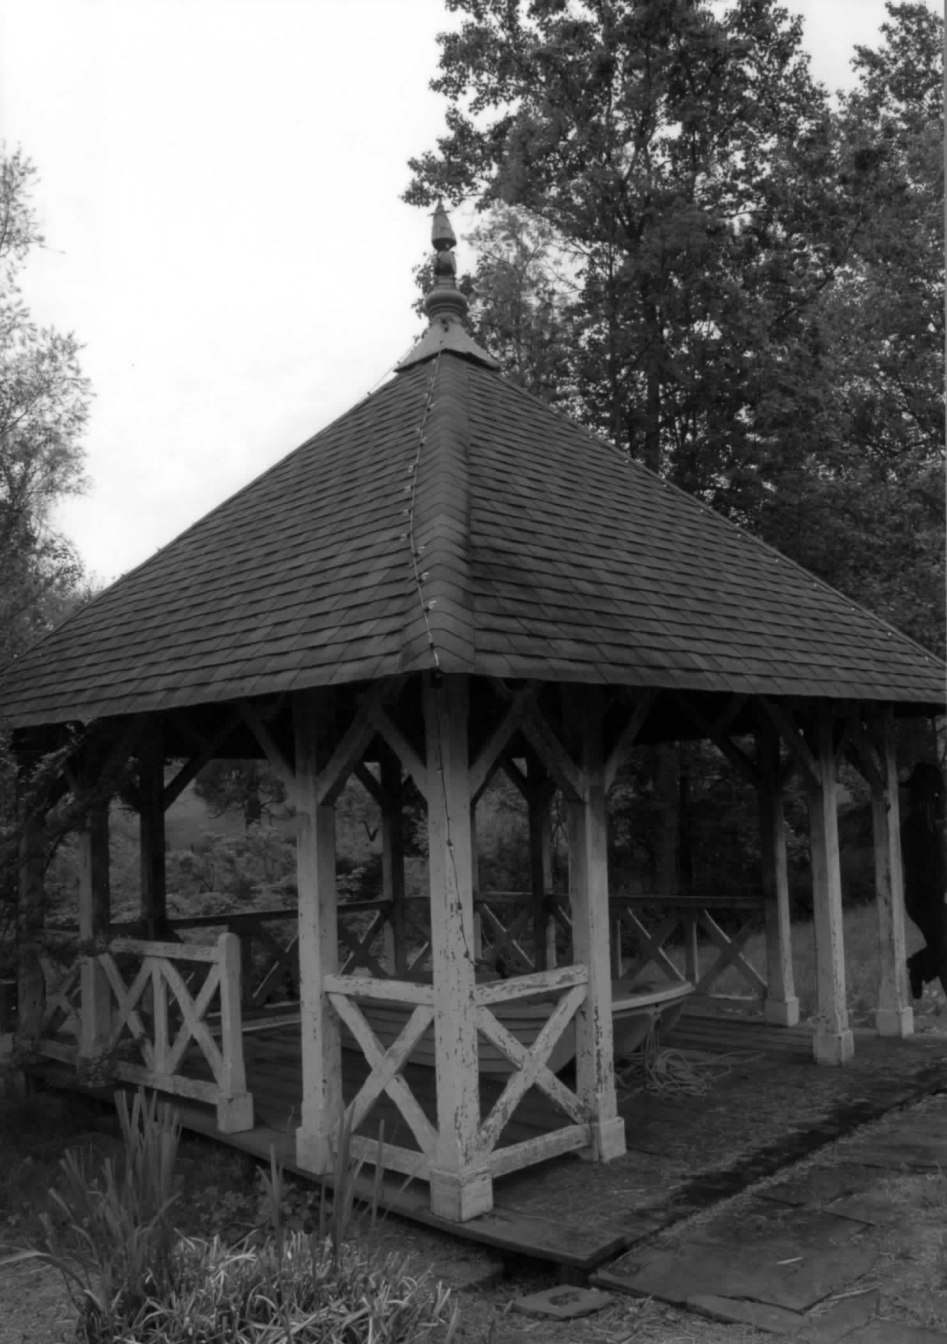
31 of 36

Gazebo, northeast + northwest  
elevations

The Gazebo is located on the south side of the pond. It is a one-story square structure with a concrete foundation and a wood board floor. It has a hip roof with asphalt shingles and a large metal finial in the center. There are square chamfered posts at the corners and set 3 feet in from the corners, with cross-buck balustrades and chamfered braces at the top. The exposed rafter ends are decoratively cut and the underside of the roof is bead-board sheathing.

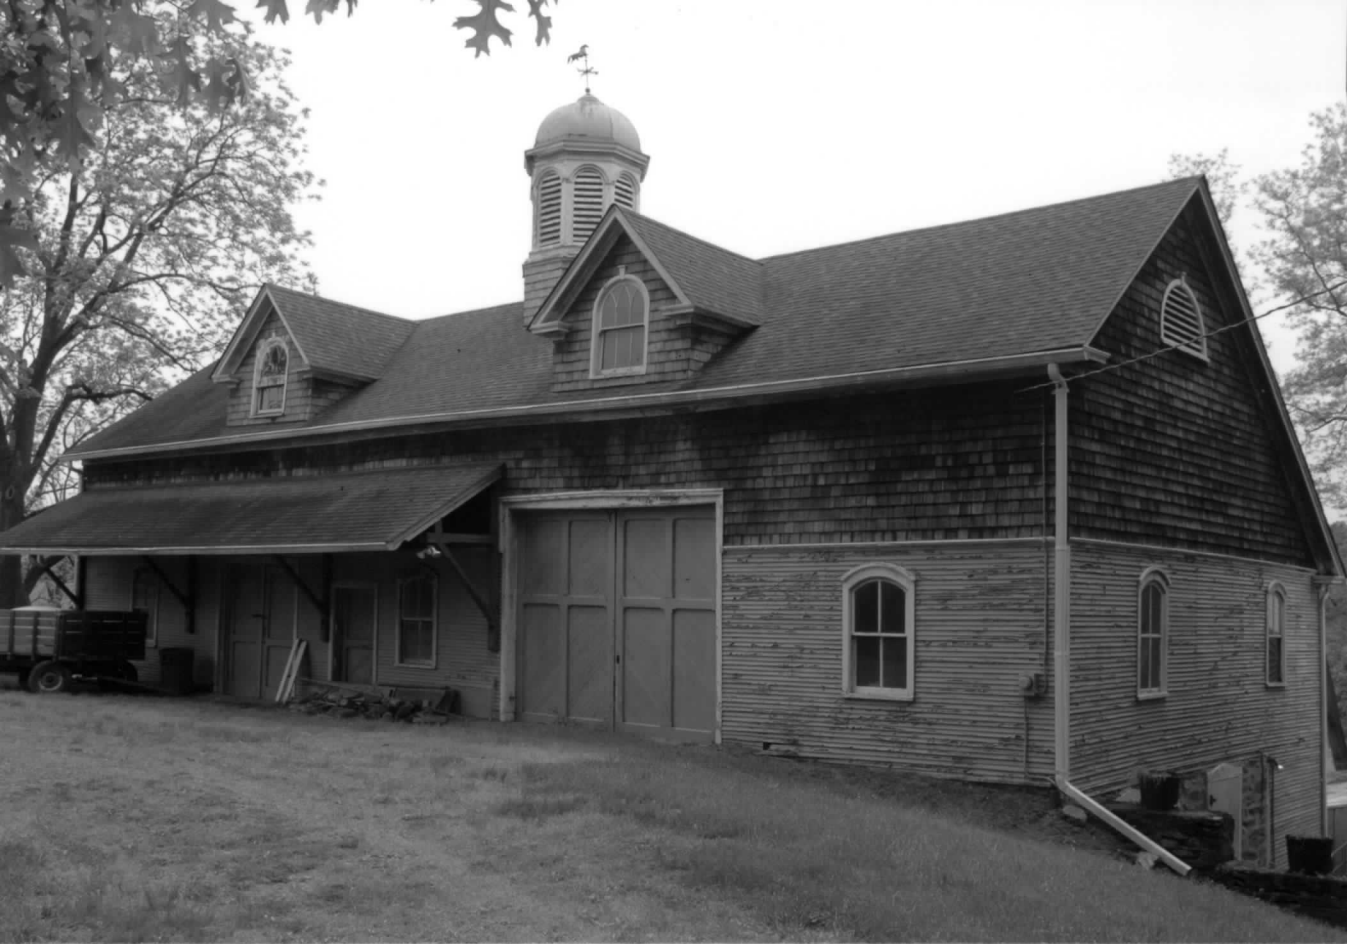
32 of 36

Stable, northeast + northwest elevations

The Stable is located about 350 feet south and downhill of the main house. It is a 1 1/2-story structure that is banked into a hill on the east, with an exposed foundation on the west, and is six bays by three bays. It has a rubble stone foundation, novelty siding of narrow, doubled weatherboards below a moulding with an ovolo above a cavetto, and wood shingles above this moulding. The roof has an uneven gable, being longer on the west, with a ridge that runs north-south and asphalt shingles. The moulding aligns with the west eave.

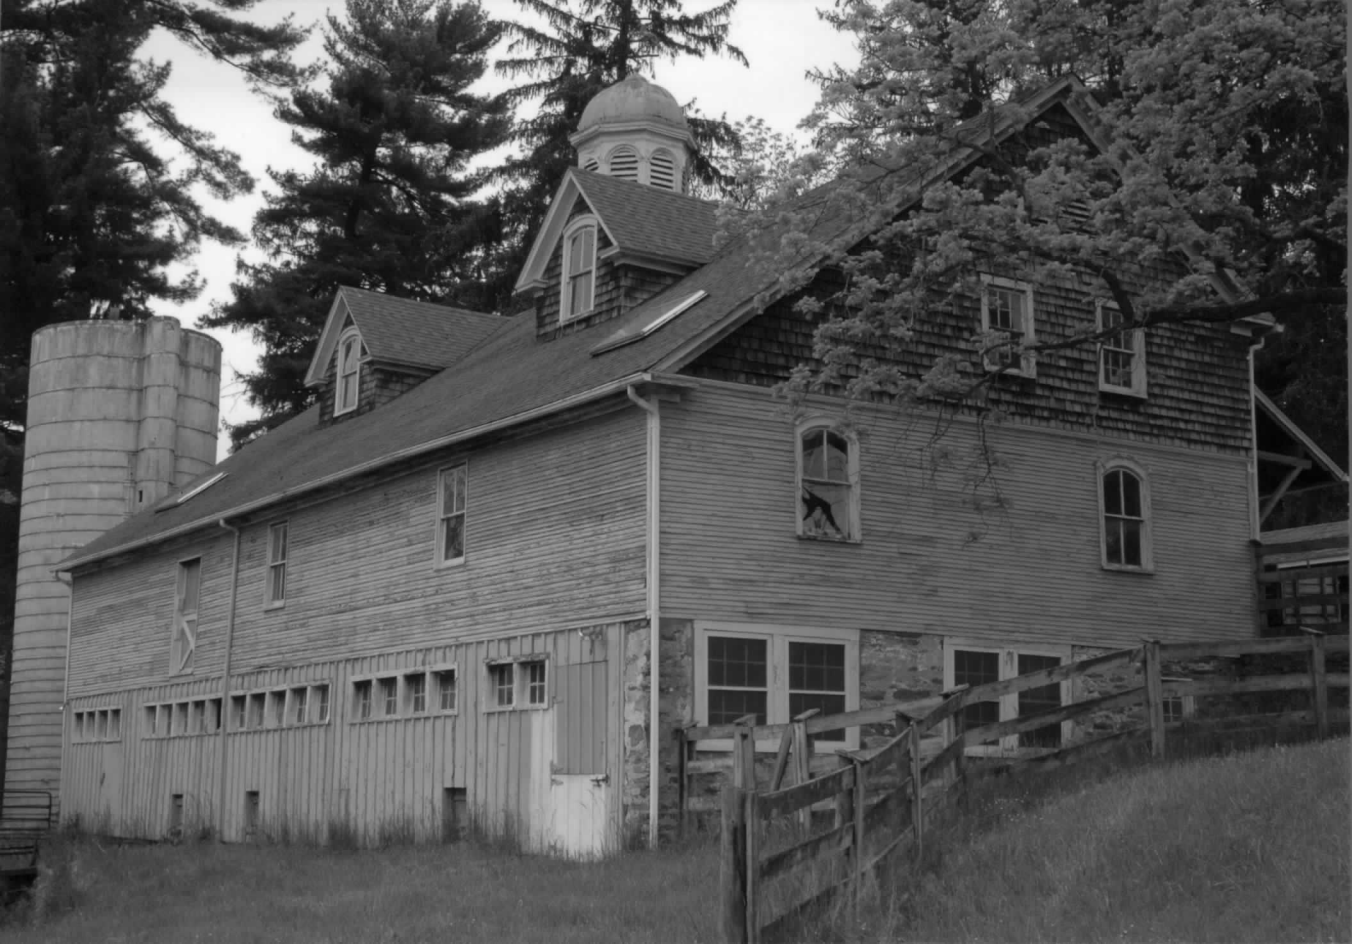
33 of 36

Stable, southwest + southeast  
elevations

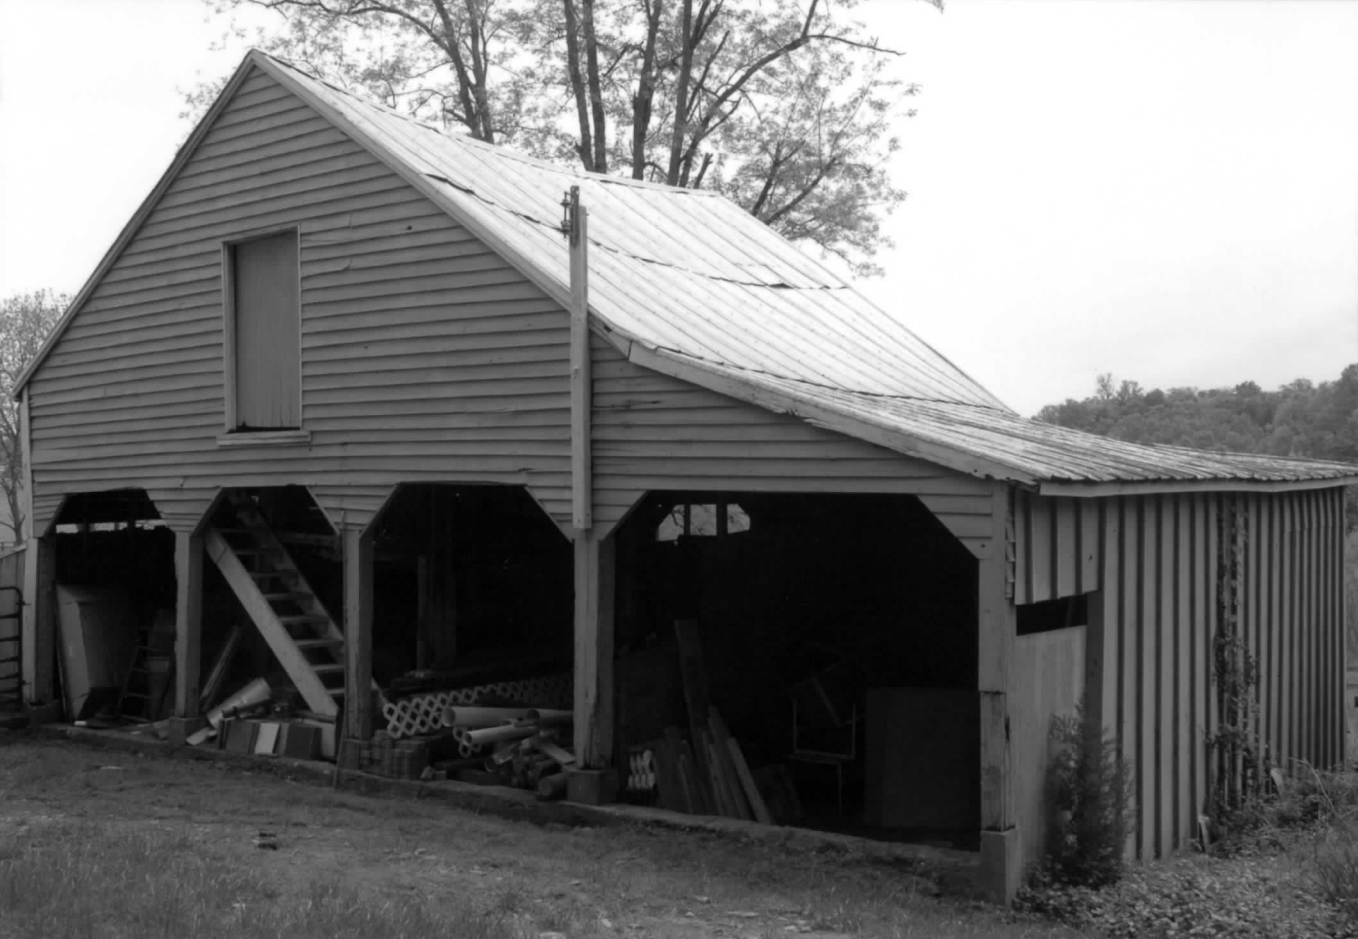
34 of 36

Wagon Shed, northeast & northwest  
elevations

The Wagon Shed/Corncrib is located about 10 feet west of the barn. It is a one-story, three-bay by one-bay frame structure with a one-bay shed-roofed addition on the northwest. It has a concrete foundation, weatherboard siding, and a gable roof on inverted-v-seam metal with a northeast-southwest ridge. The northeast elevation has four large openings, with a vertical-board door in the gable end. The southeast elevation has a short shed-roofed addition with vertical-board siding, and there are no openings above. The northwest elevation has metal siding, in a board-and-batten pattern, added and has no openings. The southwest elevation is covered by an addition that wraps around from the northwest side, with a vertical-board door in the center and six openings high on the wall to the west and eight to the south of the door. The original walls on the northwest and southwest were opened up for access to the additions.
